STATE OF CALIFORNIA
TRANSPORTATION AGENCY
DEPARTMENT OF PUBLIC WORKS
DIVISION OF HIGHWAYS

A SURVEY OF EARTH-BORNE VIBRATIONS
AT PARKSIDE MEDICAL - DENTAL BUILDING

OCTOBER 1967

Project W. O. 36418

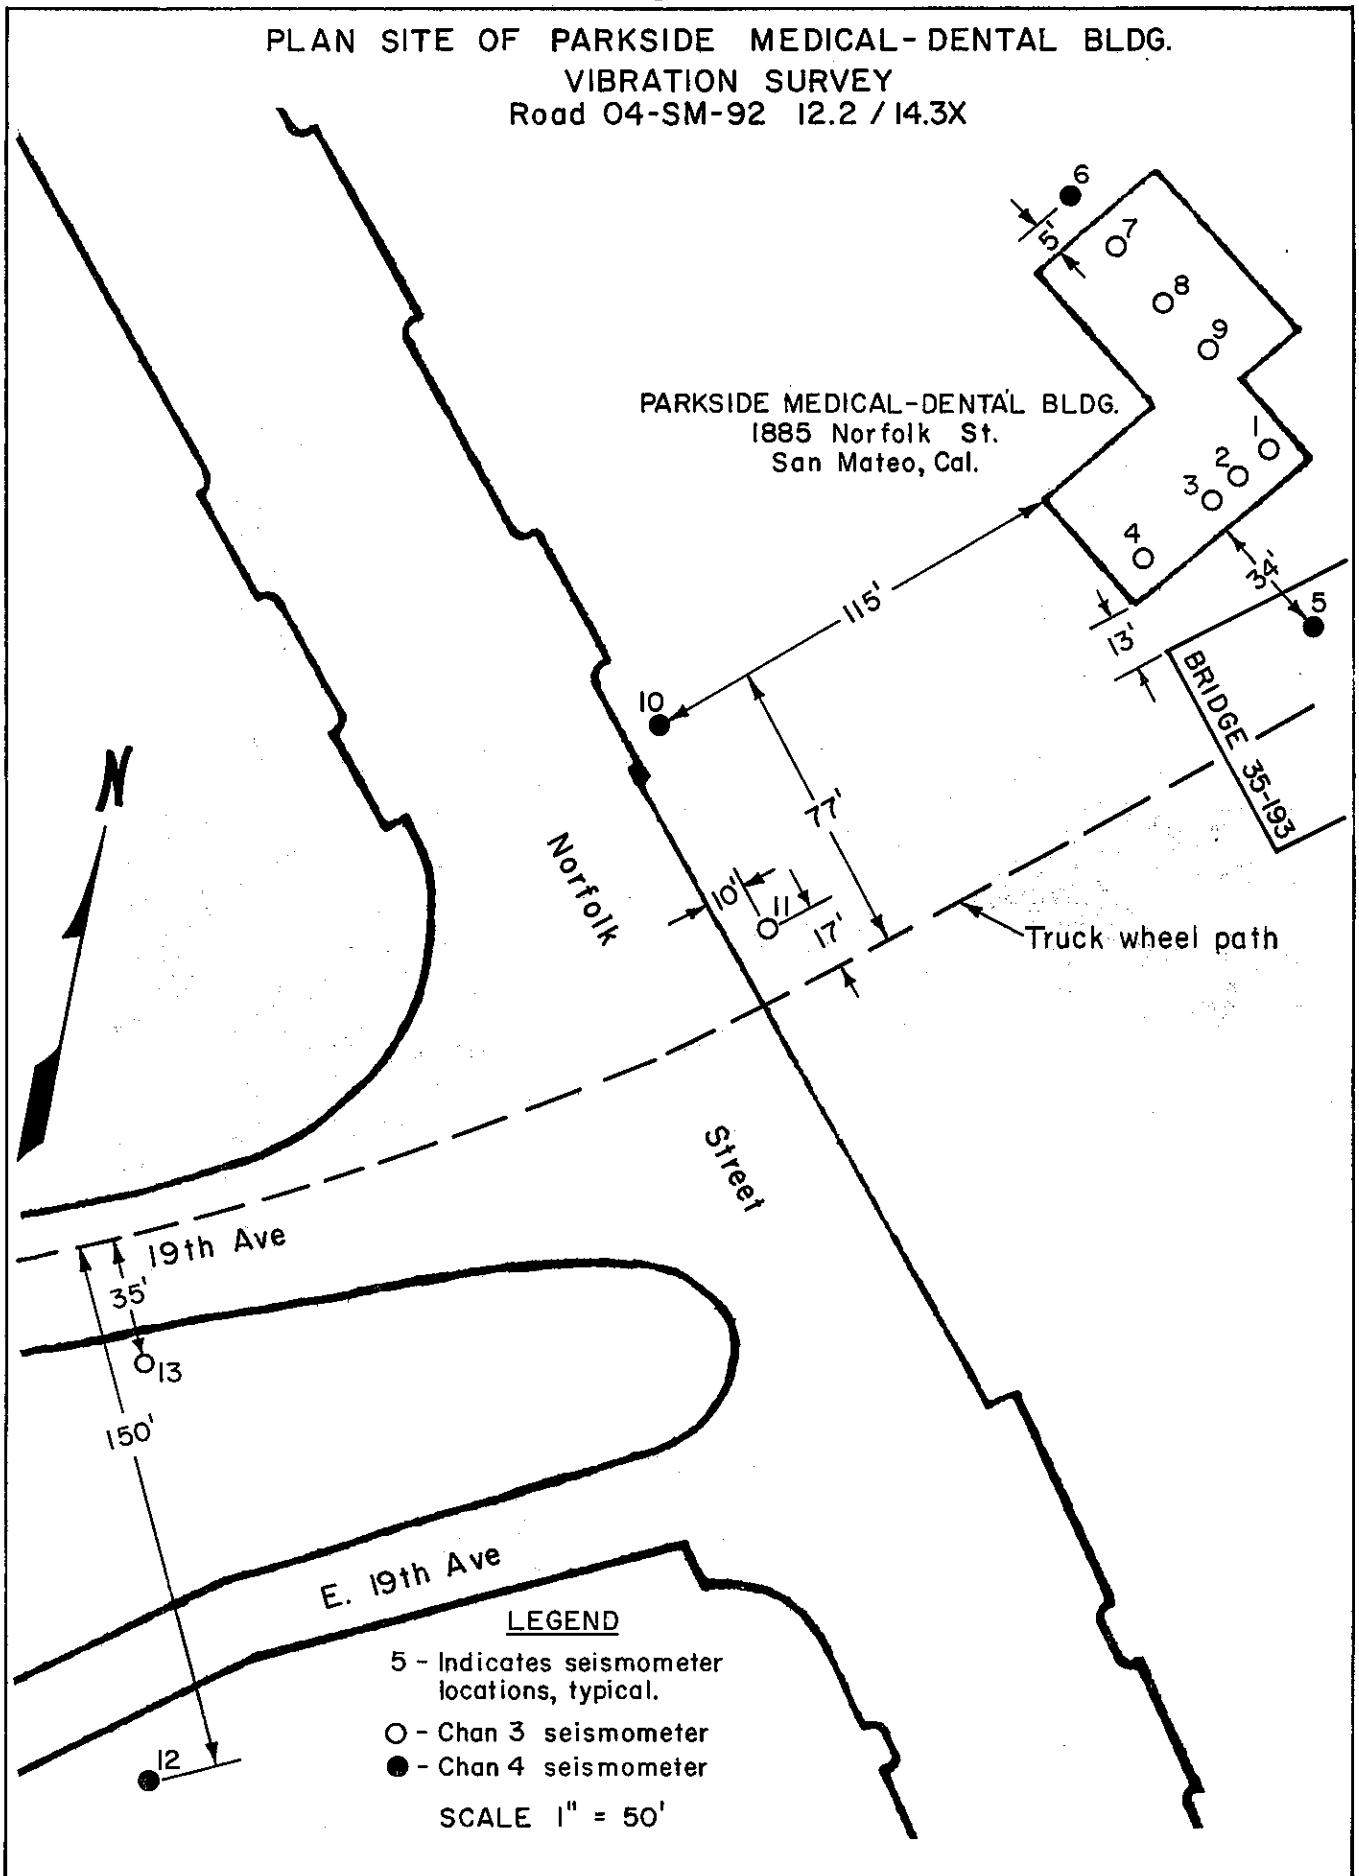
Bridge 35-193 in the City of San Mateo has recently been completed (July 1967) and will be a portion of road 04-SM-92. This bridge is not yet open to public traffic; however, the contractor routes his fill haul trucks across it in the construction of road 04-SM-92-12.2/14.3X, Contract No. 04-134644. This bridge was built within 13 feet of the Parkside Medical-Dental Building as shown in Figures 1 and 2. Mr. Grant, owner of the building, has expressed his concern that fill haul trucks crossing the bridge are shaking his building. His major concern was that the doctors' rooms - Locations 1, 2, 3, and 4 in Figure 1 - facing the bridge were particularly susceptible to vibrations emanating from the bridge.

and 4 are shown in Figures 9, 10, and 11. Of the four doctors' rooms monitored, Dr. Holtzman's Room 4 vibrated the most at 8 milli-inches and 3 cps as shown in the recording of Figure 11. This appears reasonable since his room is the closest to the bridge being 13 feet from it as shown in Figure 1.

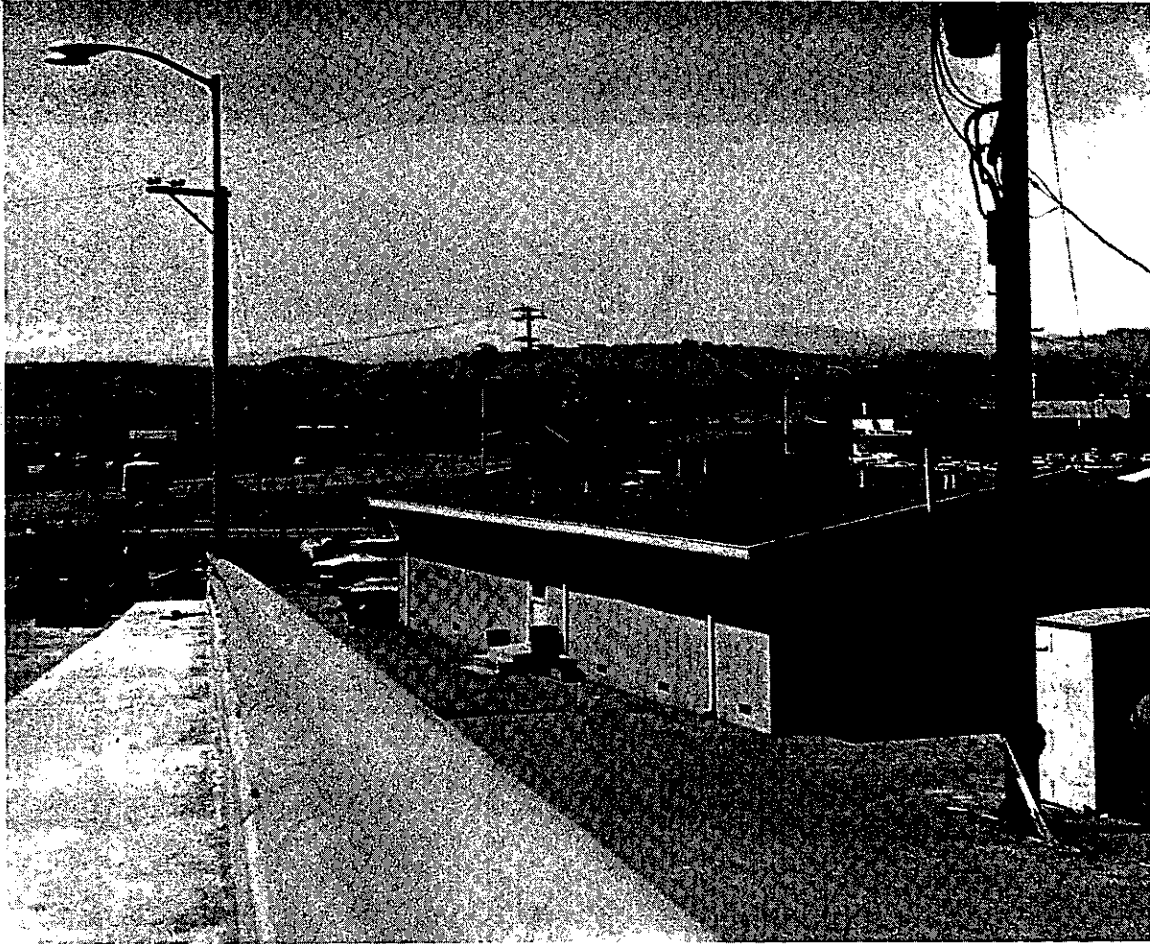
FIGURE 2

**View of bridge curb-railing and
Parkside Medical-Dental Building**

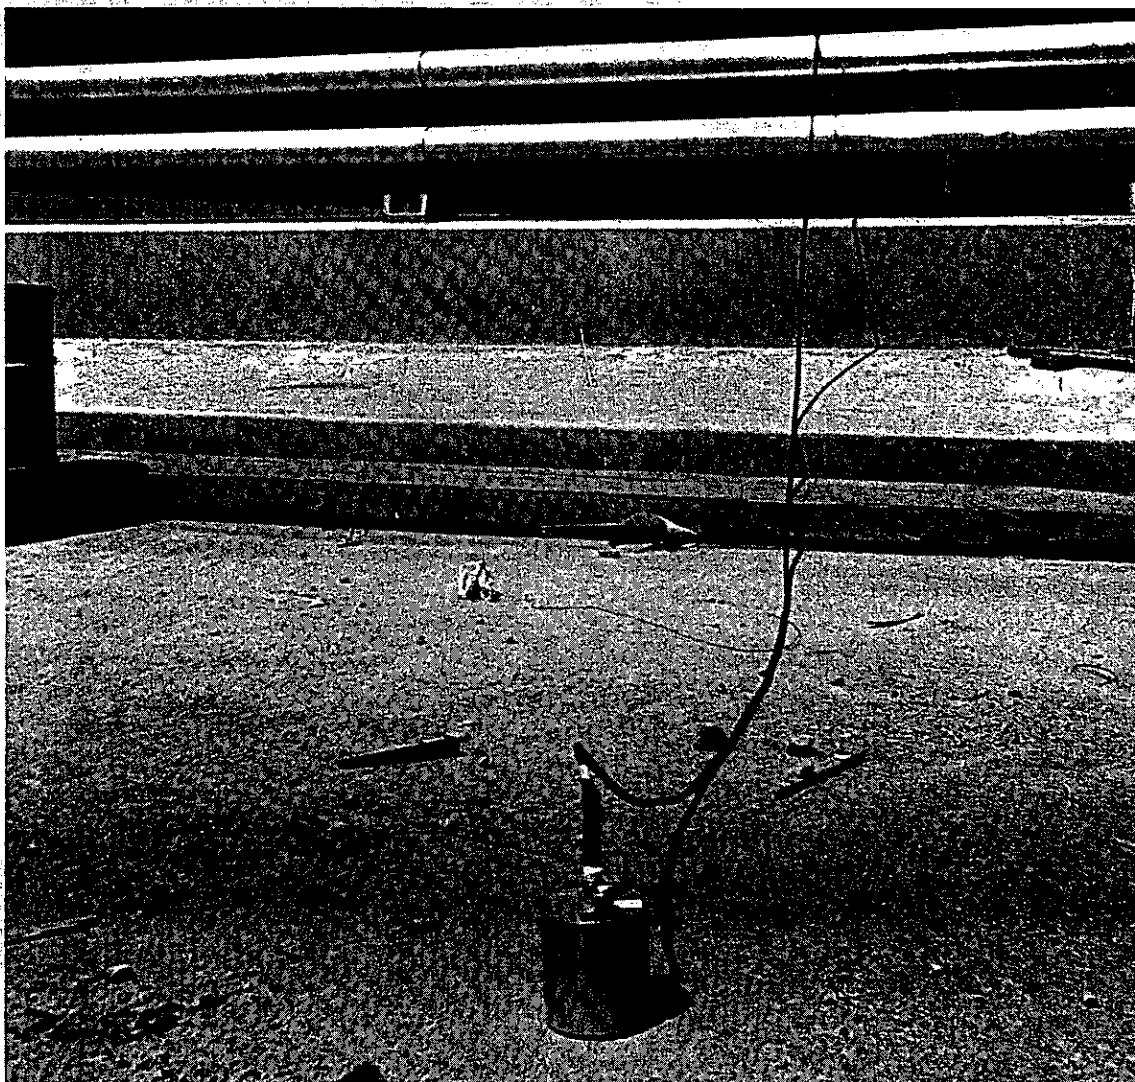
FIGURE 4

To determine the bridge deck vibrations and the amount transmitted into the medical building, one of the two seismometers was placed on the bridge deck as shown in Figure 1, Location 5. A photograph of this seismometer is shown in Figure 4. This seismometer recorded the vibrations on the bridge deck due to truck passages. The second seismometer was successively moved from one doctor's room to another, while the bridge seismometer remained fixed. The two seismometers simultaneously and respectively recorded bridge deck vibrations and room vibrations during a truck passage on the bridge. Figure 2, previously mentioned, is a plan site of the various test locations.

Seismometer on bridge deck. See
Location 5 in Figure 1 Plan Site.

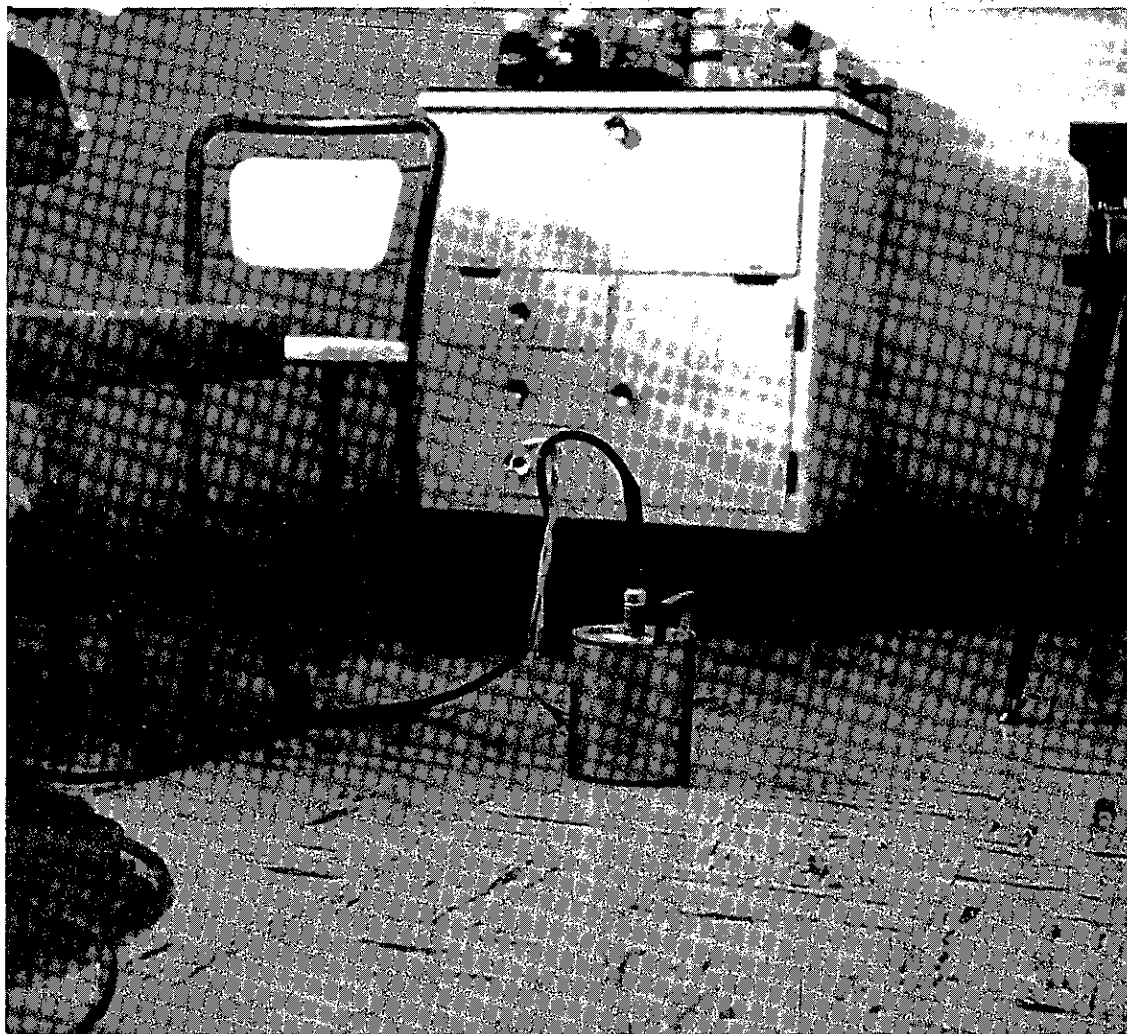
FIGURE 5

Seismometer on the floor of
Dr. Covey's Room 1.

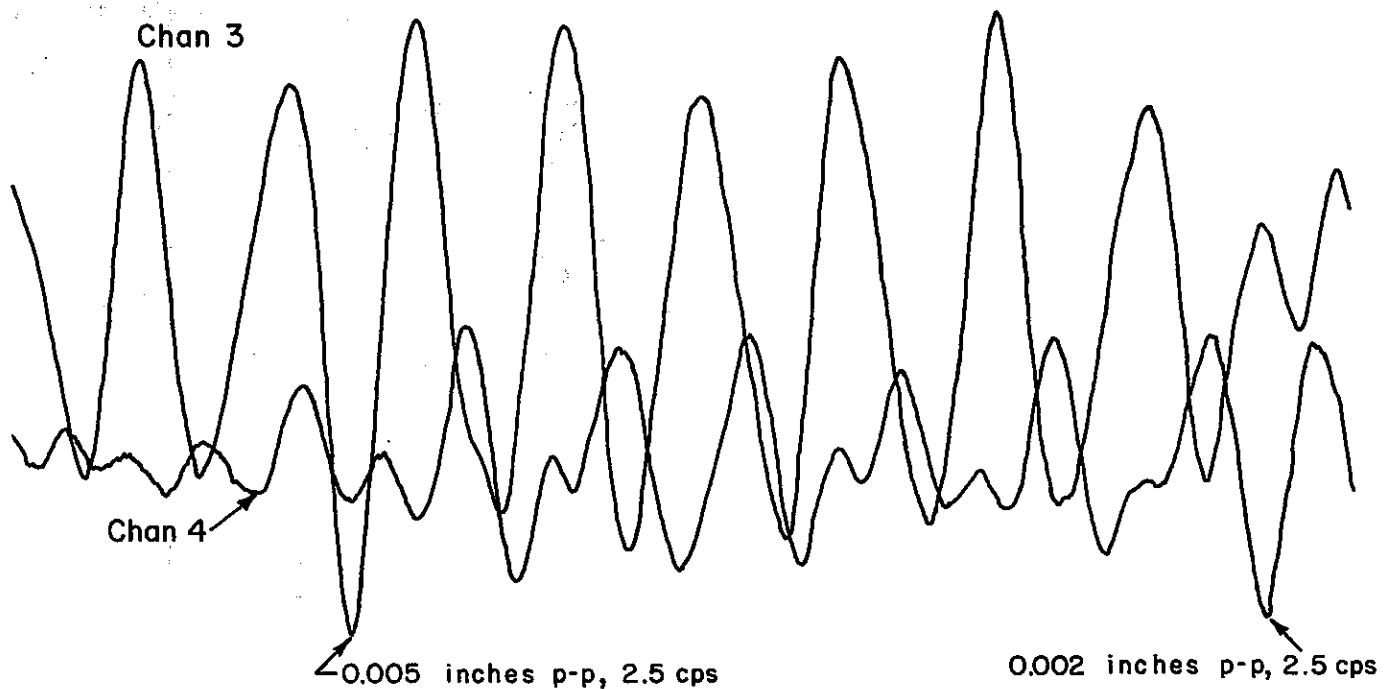
Figure 5 is a view of the second seismometer in Dr. Covey's Room 1 while Figure 6 is the record of the vibrations recorded in this room and on the bridge deck during a passage of a loaded fill haul truck crossing the bridge. This record indicates that Dr. Covey's Room 1 vibrated 5 milli-inches at 2.5 cps (cycles per second) while the bridge deck vibrated 2 milli-inches at 2.5 cps during this truck crossing of the bridge. Several truck passage recordings were made with the seismometer in Room 1; however, only the largest vibrations recorded are reported herein and similarly for the other locations throughout this report.

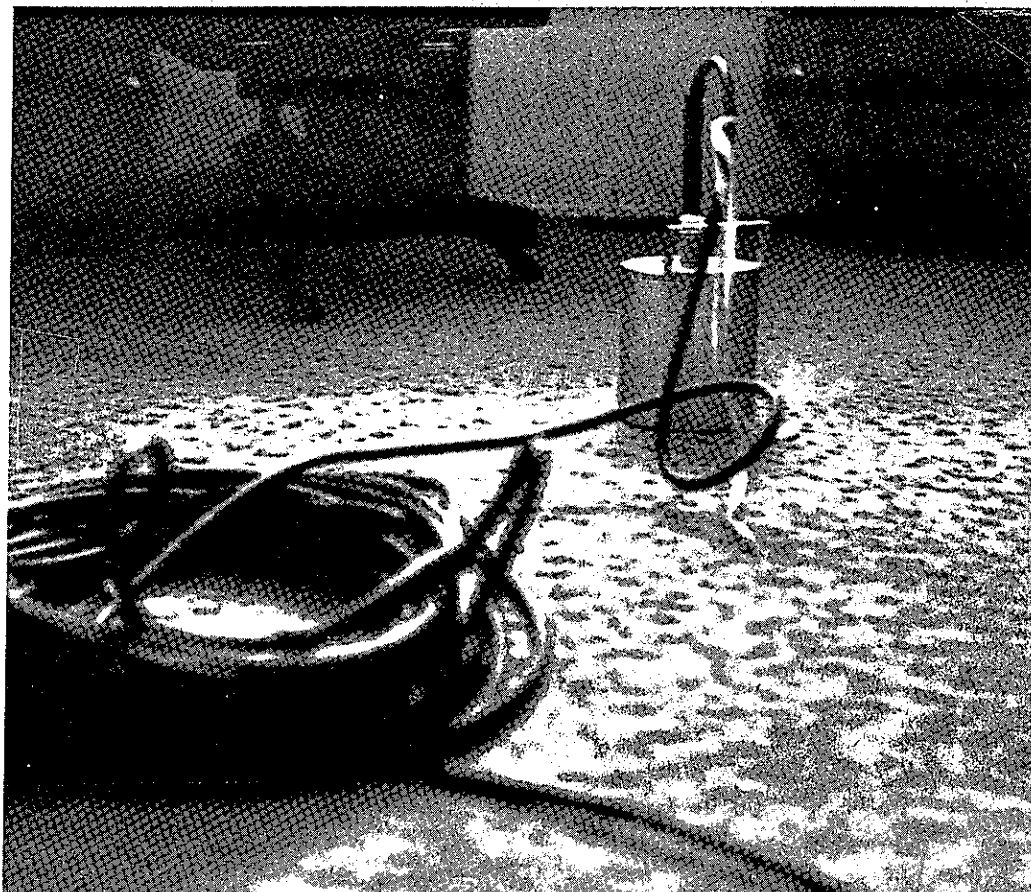
FIGURE 7

Seismometer on the floor of
Dr. Covey's Room 3.

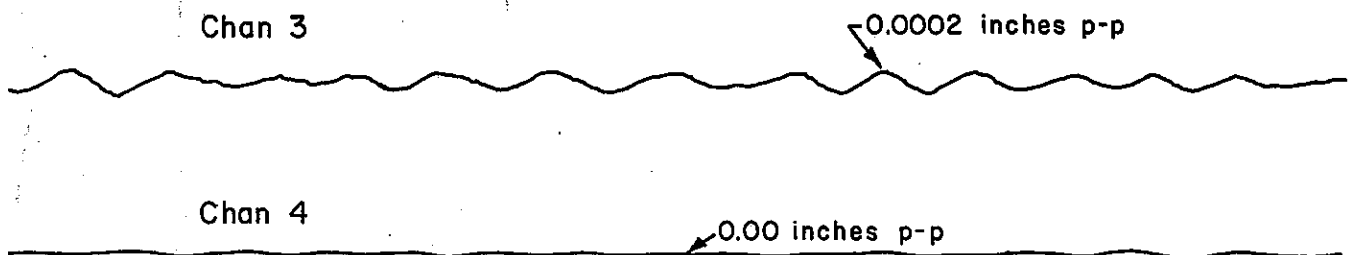
Figure 12

It was of interest to determine the amount of vibration in the building and on the bridge deck when no trucks were crossing the bridge. A recording was made of this condition in Dr. Holtzman's Room 4 and shown in Figure 12. This figure shows that the bridge was vibration free but that Room 4 had a background vibration of 0.2 milli-inches.

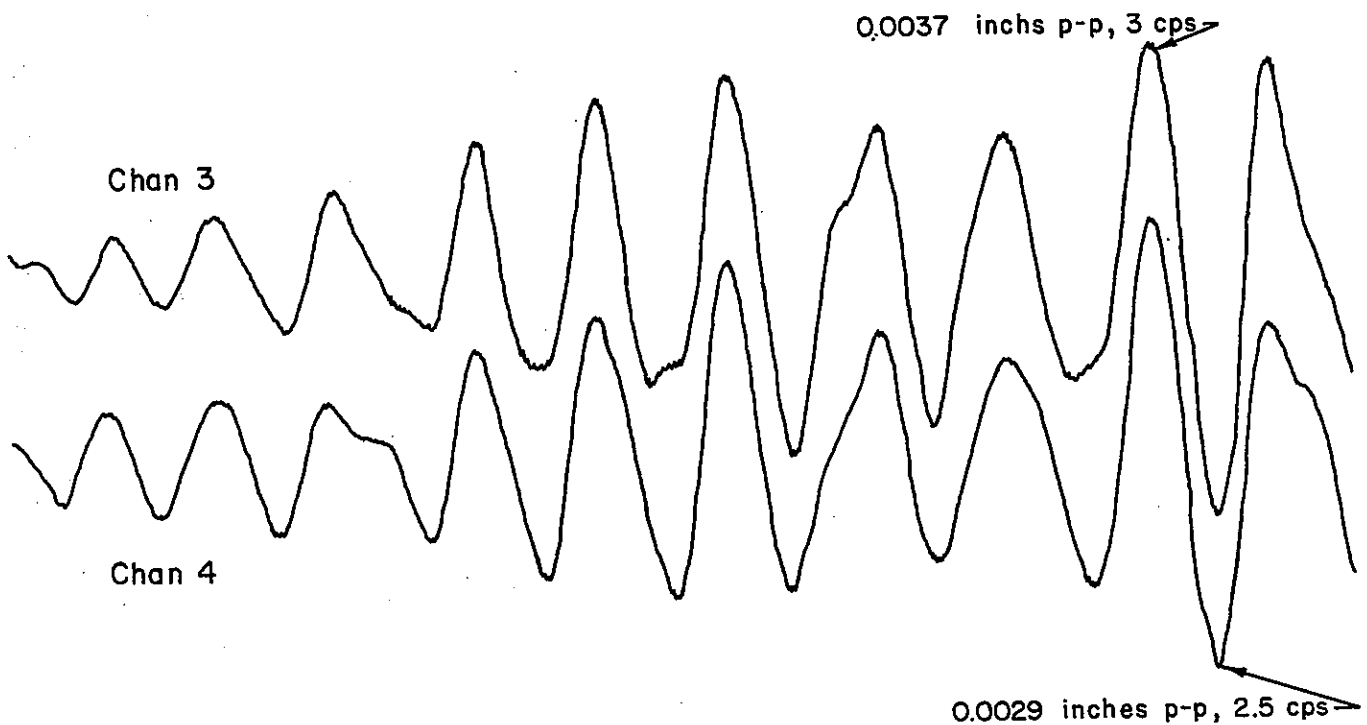
Figure 15

Mr. Grant had also expressed his concern that his office areas, Locations 7, 8, and 9 in Figure 1, were also susceptible to vibrations emanating from the bridge. Therefore a vibration survey was also conducted in that portion of his building in a similar fashion previously explained. The only difference was that the bridge deck vibrations were not monitored. The bridge deck seismometer was moved to Location 6, Figure 1, 5 feet from the building. It was of interest to record the amount of vibrations alongside of the building due to vibrations emanating from the bridge while simultaneously recording building vibrations. The results are shown in Figures 13, 14, and 15 and are self-explanatory. The largest vibration, 4.0 milli-inches at 2.7 cps, was recorded in Mr. Grant's conference room as shown in Figure 15.

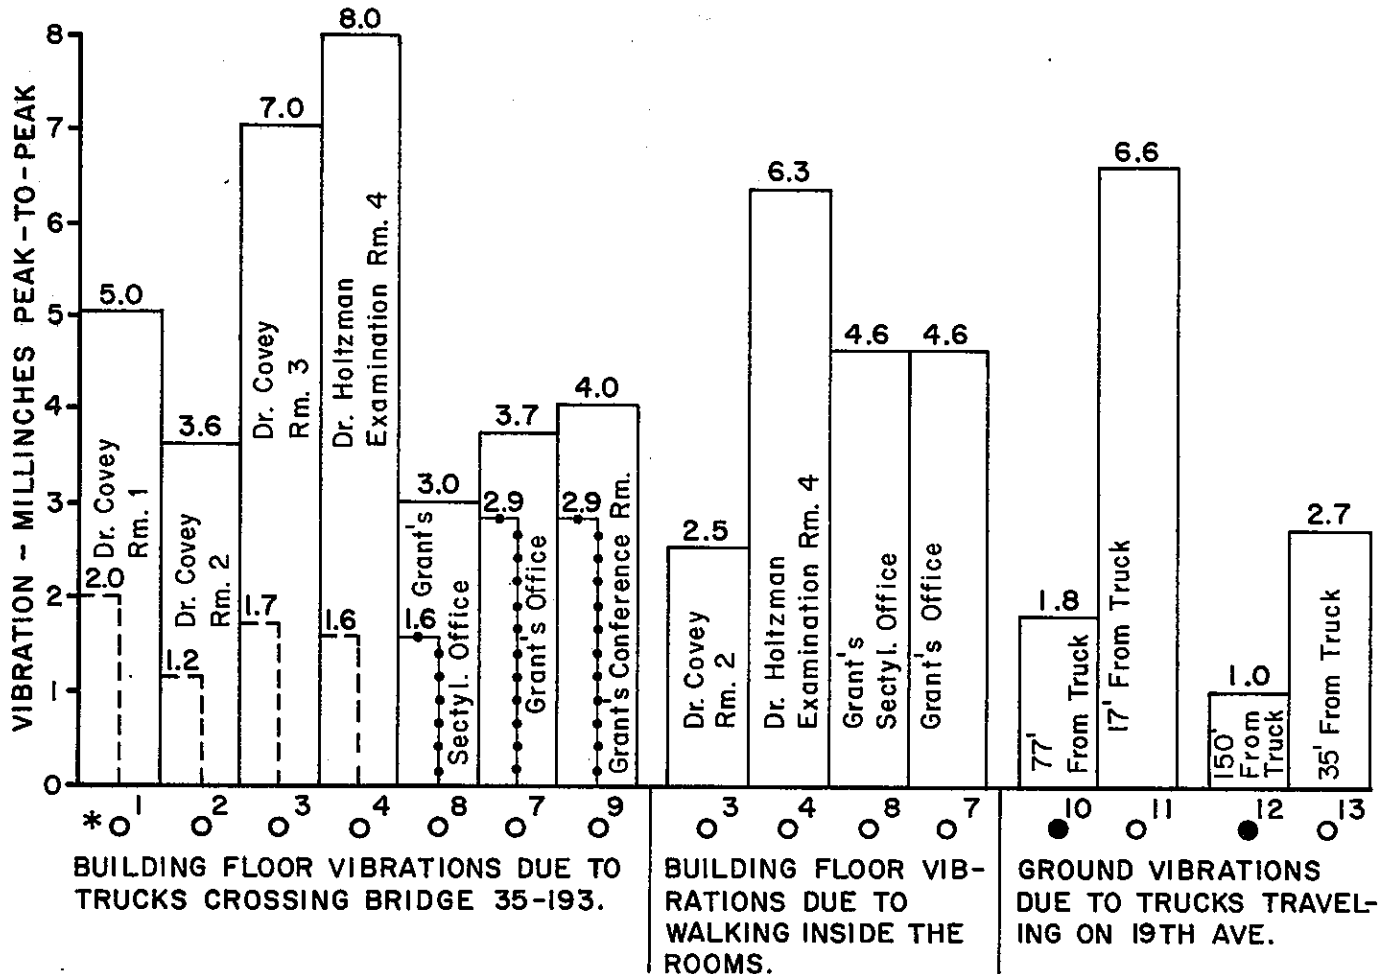
Figure 24 is a bar graph summary of the vibrations discussed in the previous pages. There is no doubt that trucks crossing the bridge are shaking the medical-dental building. The results are clearly shown in Figure 24. However, there are other contributing causes.

1. The building floor is like a sprung dance floor. The laboratory crew could definitely feel the floor vibrate as people walked around. The "walking vibrations" of 6.3 milli-inches recorded in Dr. Holtzman's Room 4 is, in many cases, more than that caused by truck traffic on the bridge. Figure 24 indicates that only Location 3 (7 milli-inches) and Location 4 (8 milli-inches) had truck induced vibrations larger than the 6.3 milli-inches of "walking vibrations". Also note that the "walking vibrations" in Grant's secretarial office and his office, 4.6 milli-inches, were larger than the vibrations on the bridge deck (1.2 to 2.0 milli-inches) due to truck traffic.

2. The bay mud ground in this area is inherently unstable so that vibrations are not attenuated but emanate for quite a distance and over a large area. This is evidenced by the vibrations measured at Locations 6, 10, 11, 12, and 13. In other words, truck traffic on the bridge structure is not the basic cause of ground vibrations. The unstable ground is its own source of vibration.

3. The natural frequency of the building floor and the ground is identical, i.e., 2 - 3 cycles per second. Any ground vibration will "couple" directly into the building floor and set the floor into resonance. This is evidenced by the large floor vibrations as opposed to the smaller exciting source vibrations, i.e., bridge deck vibrations.

The above three causes indicate that a probable vibration problem existed in the building prior to the erection of Bridge No. 35-193. It is felt that only a part of the building vibration problem can be attributed to the bridge structure.
